## UNUSUAL OCCURRENCE REPORT

1. UOR Number EG&G-85-41  
Facility Number ATR-85-8
2. Status and Date: X Initial 7-18-85  
Interim  
X Final 11-13-85

Test Reactor Area (TRA)  
Test Reactor Programs Division  
Idaho National Engineering Laboratory (INEL)

Spread of Radioactive Contamination, Firewater Line Separation

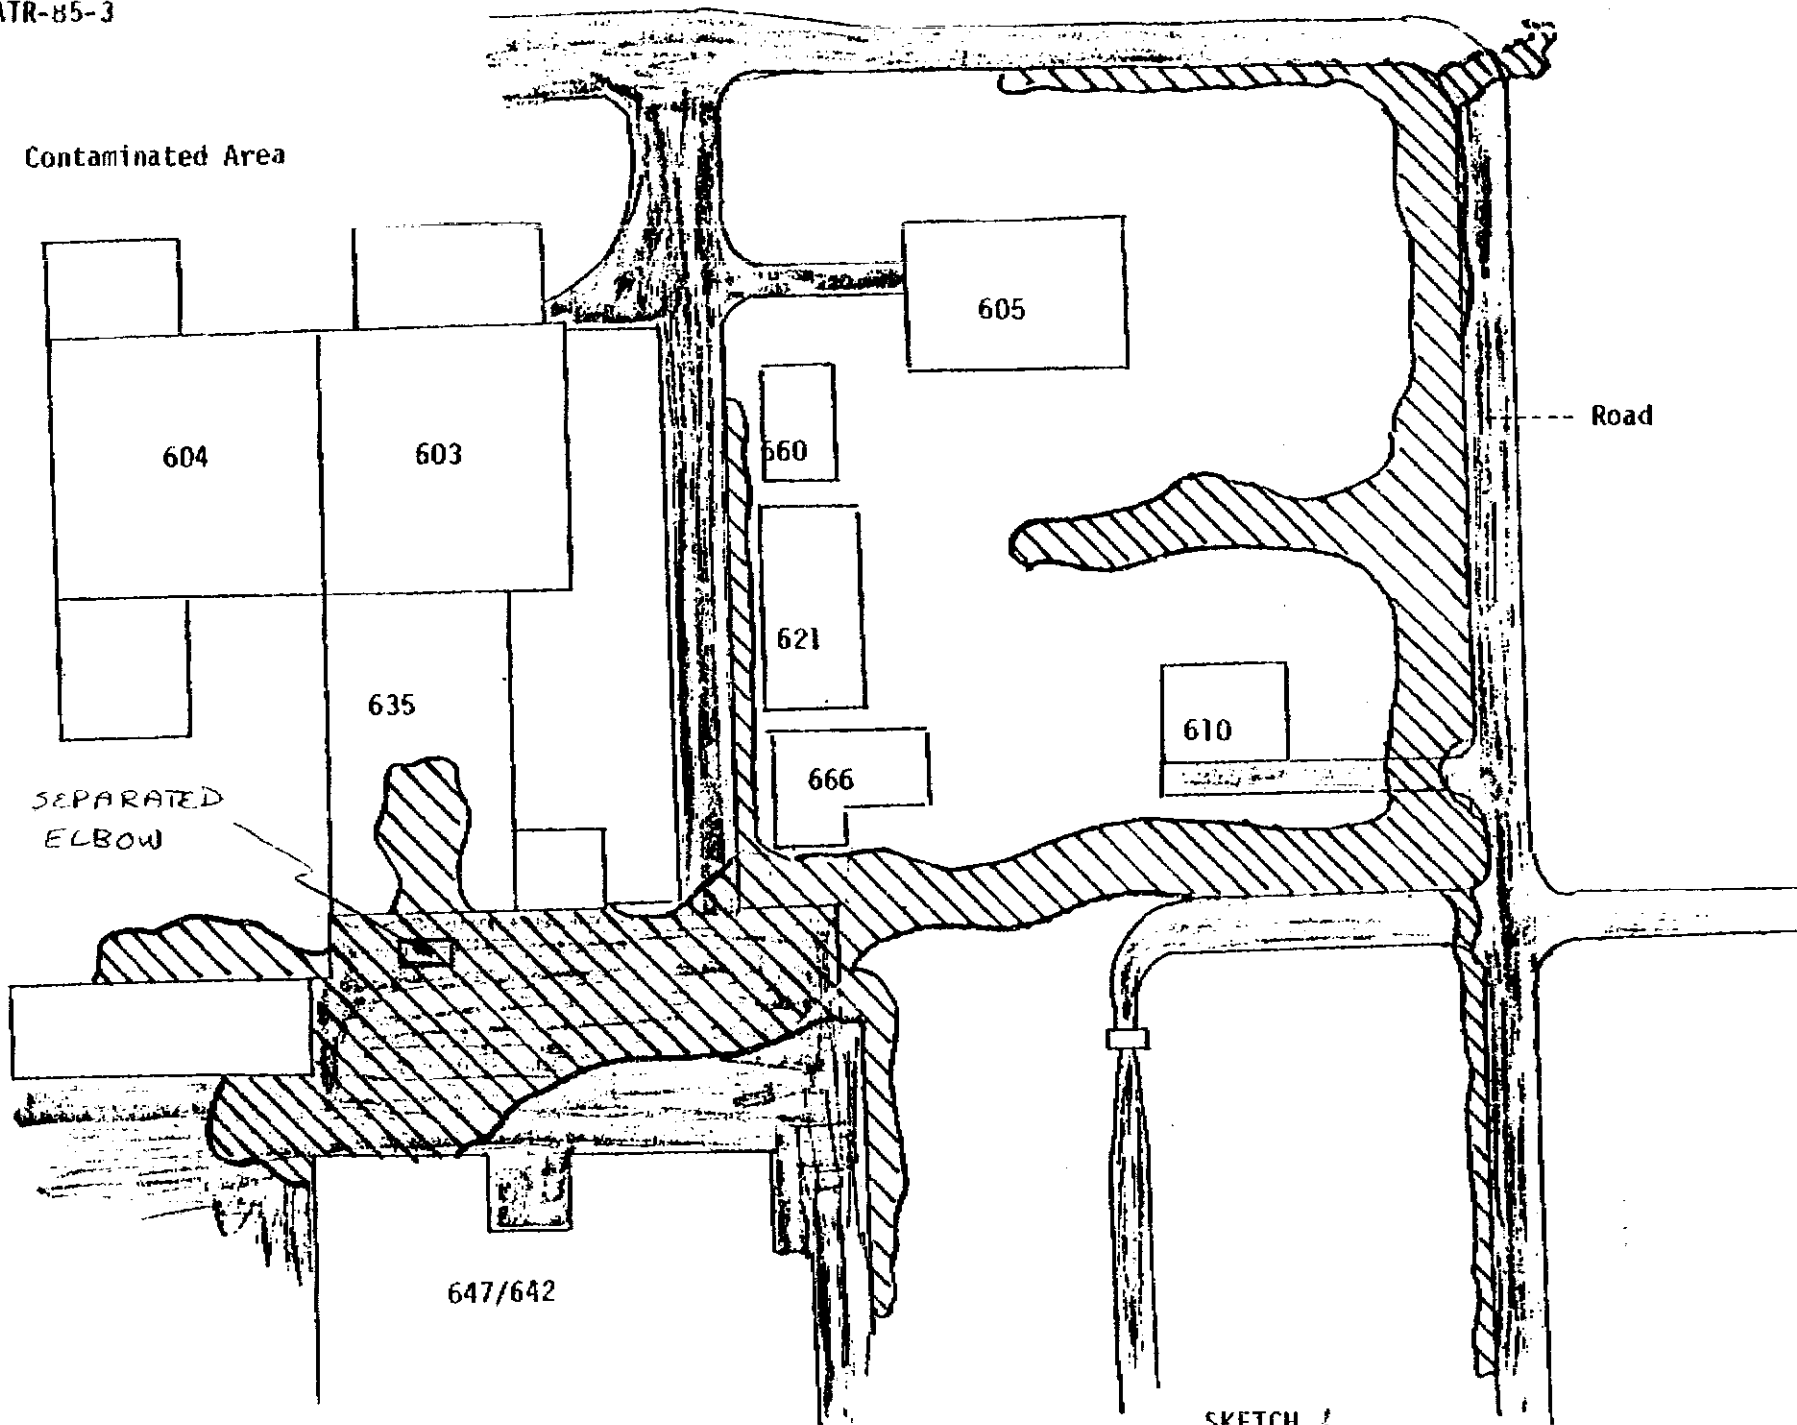
SKETCH 1

Following the fire main separation, low level contamination was spread over a large area in the Southeast corner of the TRA. The probable cause of the fire main separation was movement of the newly installed thrust block allowing separation of the fire water line.

Contaminated Area
